Assessment of a membrane drinking water filter in an emergency setting

Jeroen H. J. Ensink, Andy Bastable and Sandy Cairncross

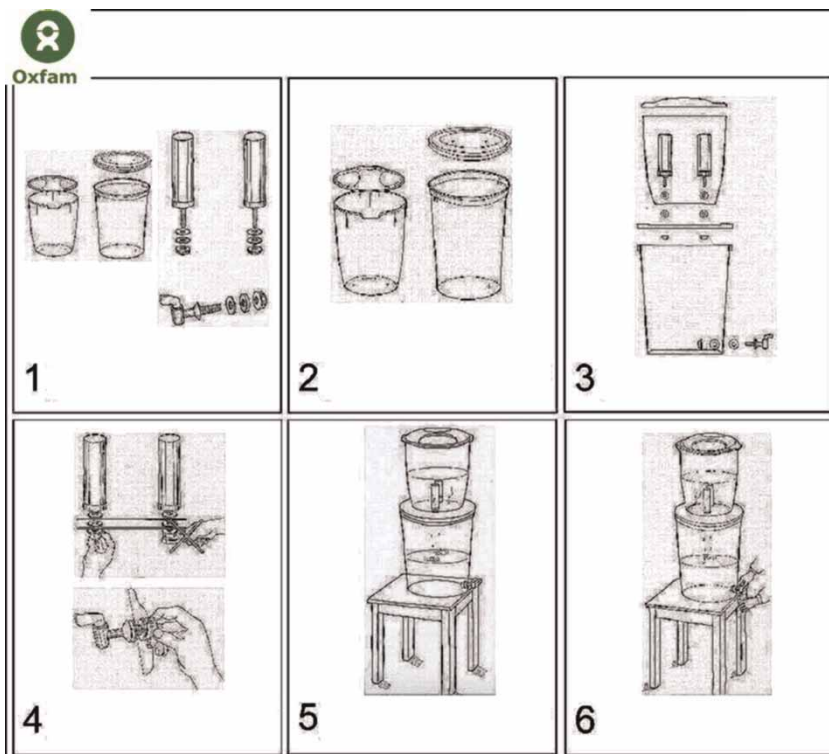
Figure 2 | Diagram showing the use of ceramic filters.
