## **Surface Water Treatment in Palorinya Refugee Settlement, Uganda**

Palorinya surface water treatment plant, Uganda - set-up, upgrades, operational guidance, lessons learnt and recommendations.

Fred Liesner, (Fred.liesner@gmail.com), MSF-OCA WatSan,

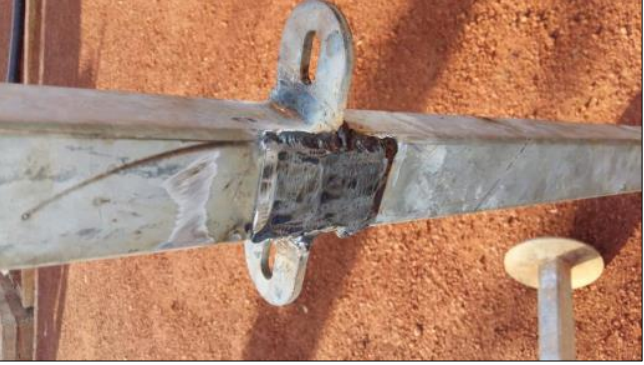
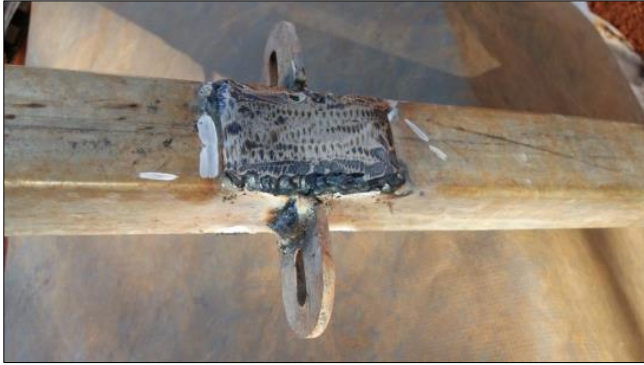
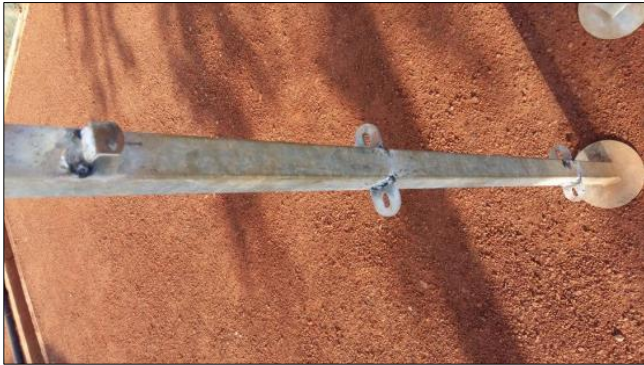
| No. | ISSUES | RECOMMENDATIONS |
|---|---|--|
| 1 | <p>After less than three months of service there were several welds cracking on the upright columns of the frame. These were from Labaronne-Citaf company.</p> <p><i>Photo 1: Detail of repair to 30m<sup>3</sup> metal frame tank upright</i></p> <p><i>Photo 2: Detail of repair to 30m<sup>3</sup> metal frame tank upright</i></p> <p><i>Photo 3: Locally completed welds on 30m<sup>3</sup> metal frame tank uprights</i></p> | <p>This only happened on the model that made use of one-piece uprights, not the version with the uprights in 3 sections.</p> <p>Improve build quality with better quality welding and material selection.</p> <p>Note that the team also received some of the kits (Labaronne-Citaf) with welds missing on the vertical posts; these were rewelded in the field at a local metal shop.</p> <p>The workmanship of these items is poor. The tool kit includes a file for the removal of burred edges left on vertical post unions.</p> <p>Labaronne-Citaf need to follow-up on quality control in their factories.</p> |
